Lessons From the Field: Vacuum System Performance Surveys

Applying techniques discussed in issue four to solve real world vacuum equipment performance problems

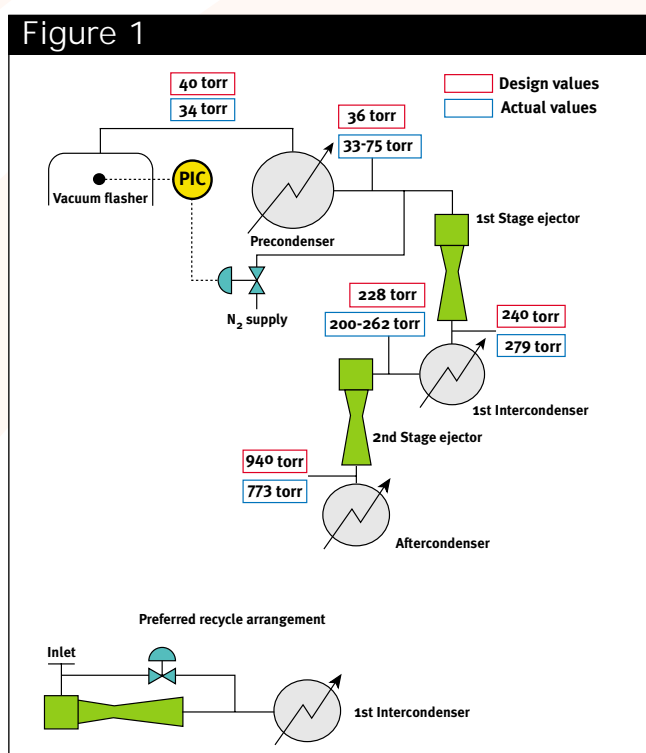
The precondenser produced adequate vacuum but the two-stage ejector system that extracted noncondensables from the precondenser was performing in an unstable manner. Suction pressure of the first-stage ejector was cycling between the design 35 torr and as high as 75-80 torr.

The ejector system manufacturer supplied both the precondenser and vacuum system. The manufacturer dispatched a service engineer to the site to survey the equipment and its performance. Figure 1 depicts the pressure profile of the equipment.

An ejector system with unstable suction pressure typically is operating in a broken mode. A broken ejector often is caused by low motive steam pressure, a fouled intercondenser, high cooling water temperature or low cooling water flow, or excessive noncondensable loading.

While inspecting the ejector system, the service engineer noticed a periodic audible change in ejector operation. This audible change plus an unstable suction and discharge pressure for the first-stage ejector confirmed this particular ejector was the trouble.

The service engineer noticed plant personnel had installed a pneumatic control valve that bled nitrogen to the suction of the first-stage ejector. Plant personnel installed a nitrogen bleed to control suction pressure so the vacuum flasher would operate at a consistent pressure, even at reduced charge rates. Pressure in the top of the vacuum flasher was sensed and a signal sent to the control valve to bleed nitrogen to the first-stage ejector if the vacuum flasher pressure fell below design.

Bleeding nitrogen, which is noncondensable, to the suction of a multistage condensing ejector system will result in unstable performance.

An ejector system is designed to handle noncondensable loading associated with the process. Ejectors downstream of the first intercondenser are designed to handle process-related noncondensables and associated saturation vapors. Bleeding in nitrogen to act as an artificial load for the first-stage ejector and to elevate suction pressure resulted in noncondensable overloading of the downstream ejector.

The service engineer instructed plant personnel to disassemble the nitrogen bleed arrangement and to install recycle control piping around the first-stage ejector or bleed nitrogen

to the inlet of the precondenser. For any multistage condensing ejector system the preferred way to maintain performance and suction pressure is to recycle discharge from an ejector immediately preceding the first intercondenser back to the suction of the system. In this way, noncondensable loading is never allowed to increase above design, ensuring broken ejector operation will not occur. Again, vacuum flasher pressure is sensed and a signal sent to the recycle control valve, which will modulate and permit the recycling of vapor flow back to the suction of the first-stage ejector. Once the plant installed this form of recycle control, stable ejector operation was maintained.

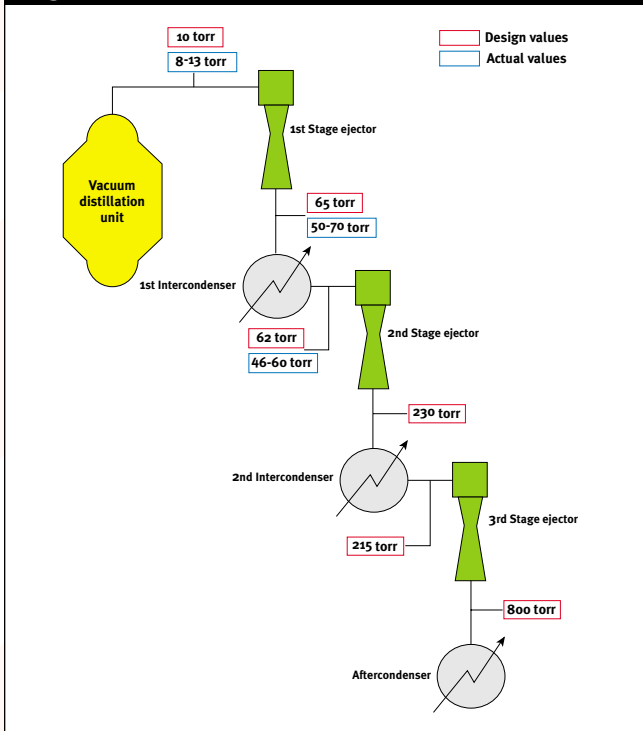
Figure 2

A West Coast petrochemical plant was operating a fuels vacuum distillation unit that experienced erratic performance after replacing an intercondenser supplied by the original ejector system manufacturer with one designed and built by a local heat exchanger fabrication shop. The system was designed to provide performance as described by Figure 2. The service engineer did not know the user installed a replacement intercondenser.

The first-stage ejector was operating in a broken mode, with both suction and discharge pressure remaining unstable. Furthermore, shellside pressure drop across the first intercondenser was almost three times the design pressure drop.

Upon visual inspection of the installed unit and its nameplate, the service engineer realized it was the design of another vendor. That vendor did match the original intercondenser's tube count and external dimensions, but after a thorough review of fabrication drawings, it was evident the vendor failed to properly design the shellside baffling to effectively manage hydraulic and thermal requirements. Vacuum condensers have special shellside baffling to ensure minimal pressure drop, noncondensable gas cooling, and separation of

noncondensables and condensate. It is typical to have different baffle spacing at strategic locations within the shell of a vacuum condenser or to incorporate a long air baffle design. The vendor who replaced the intercondenser used conventional software to model the performance. This in turn resulted in a design having fully baffled flow, and consequently, excessive pressure drop on the vapor side.

In this particular instance, high-pressure drop across the shellside caused the system to break performance. The first-stage ejector could not overcome the added pressure drop and reach a discharge pressure where the second-stage ejector would operate. This discontinuity resulted in the first-stage ejector breaking operation, which was characterized by unsteady suction pressure and back streaming of motive steam into the vacuum distillation tower. Both performance conditions were unsatisfactory to the refiner.

Although the plant engineers were reluctant to accept the condenser as the problem, they did agree to install a new condenser designed by the ejector system manufacturer. Once the properly designed condenser was installed and the system restarted, performance was returned to a satisfactory level.

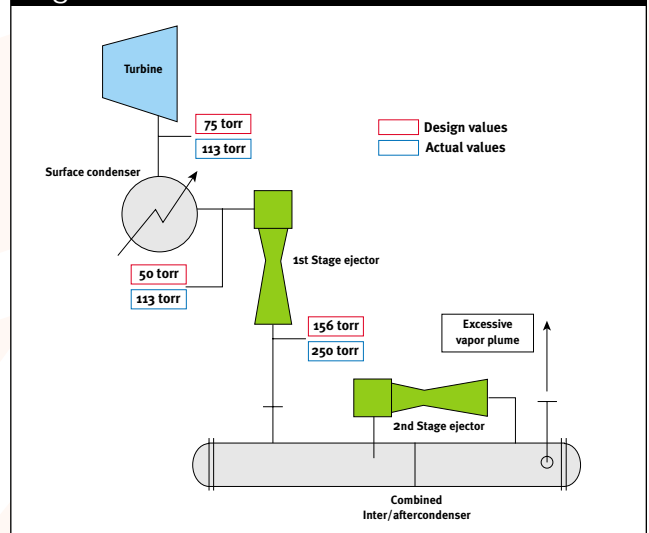
An ammonia plant SYNGAS compressor provided less than designed horsepower due to high back pressure from a condensing turbine steam surface condenser. The turbine exhaust condenser maintained 113 torr backpressure, but based on the cooling water temperature, the expected backpressure should have been 75 torr. A service engineer was dispatched to the site to evaluate the steam surface condenser and ejector performance to determine the cause of the elevated backpressure.

A two-stage ejector system as illustrated by Figure 3 supported the steam surface condenser. The service engineer noticed a substantial exhaust plume from the aftercondenser vent.

Normally, steam surface condenser and ejector systems are vacuum tight, with air leakage less than Heat Exchange Institute design values, with typical air leakage of 5 lbs./hr. or less. An excessive exhaust plume from an aftercondenser suggests high air leakage. There was an air leakage meter installed on the vacuum system and, when activated, the measurement was off the scale.

The condenser was isolated from the vacuum system and pressure stayed fairly constant. This confirmed the air leakage was downstream of the condenser and that it was in the ejector

system. A closer look at the installation determined that a $\frac{3}{4}$ inch instrument connection was unplugged. The open connection permitted substantial quantities of air to leak into the ejector system and cause poor operation. Once plugged, the entire condenser was then brought on line and after the system was allowed to stabilize, steam surface condenser operating pressure reached the expected 80 torr. The SYNGAS compressor returned to full power once this correction was made.

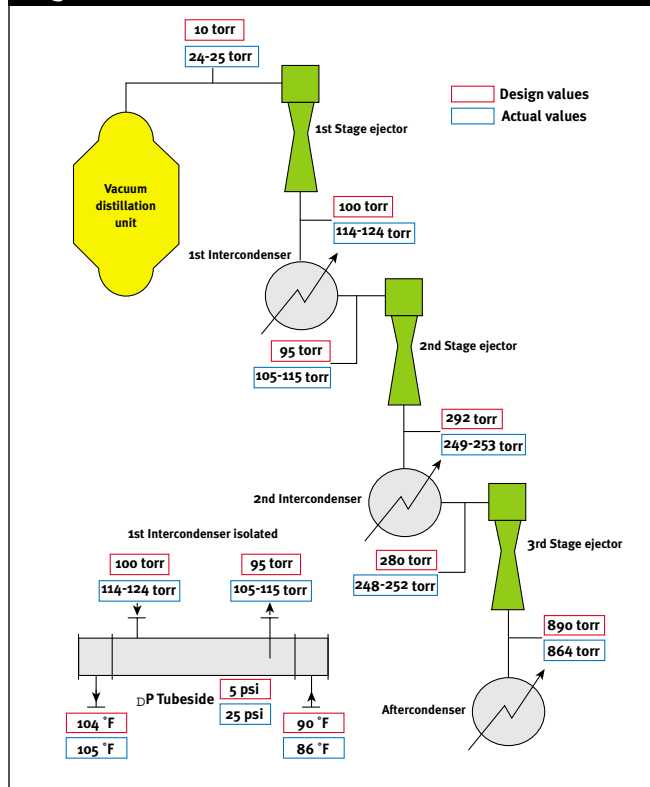
A Gulf Coast refiner was operating a damp crude vacuum distillation tower designed for 10 torr tower top pressure but was maintaining only 24-25 torr. The first-stage ejector was surging and back streaming into the vacuum distillation unit. Figure 4 documents as-sold performance and what was measured in the field.

Design cooling water temperature rise across the first intercondenser was 14°F (7.8°C), however, the actual temperature rise was 20°F (11.1°C). Possible causes for an elevated temperature rise would be lower than designed cooling water flow or an increase in condensable load to the condenser. Pressure drop across the tubeside of the condenser indicated something was wrong. The actual tubeside pressure drop was 25 psi (1.7 bar) while the design was only 5 psi (0.35 bar).

To produce such an elevated pressure drop, tubeside fouling would be severe and actual tube blockage must have occurred.

The first-stage ejector could not overcome the elevated shell-side pressure drop and, consequently, broke operation. The broken operation resulted in unstable suction pressure, surging and back-streaming of motive steam into the vacuum distillation unit. The first intercondenser was pulled from the platform and taken down to grade. At grade, the bundle was removed to inspect the shellside for fouling and to rod out the tubes. The shellside did not experience excessive fouling but the tubeside

had tubes blocked with solidified calcium carbonate and other soluble salts.

Once the tubeside was cleaned and returned to acceptable condition, the bundle was reinstalled in the condenser, and the condenser reattached to the vacuum unit. Back in service, the system's tower top pressure was maintained at approximately 10 torr and performance was stable.
