Maintenance and turnaround planning critical to successful ejector vacuum system operation

Highlighted below are four such case studies, which have been selected from a pool of examples and represent real issues that have been faced by plants of various industries. The case study examples highlight the thought processes that lead to these errors and detail the impact that these errors had on the vacuum system's operation.

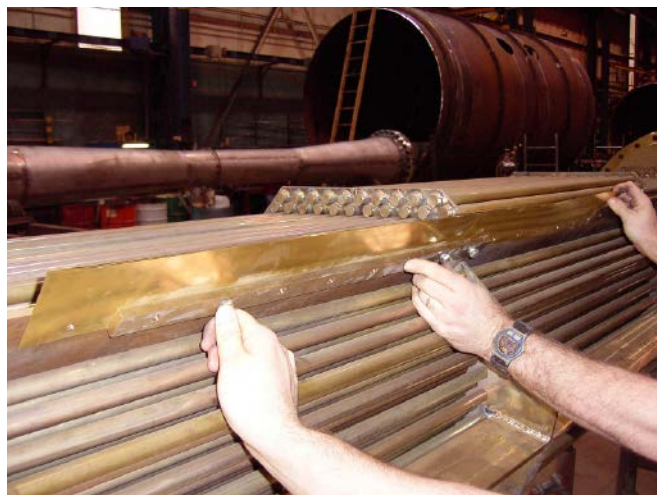
Condensers can be supplied in a variety of different configurations, and fixed tubesheet designs are one of the most basic arrangements. In a fixed tubesheet design, the tubesheets are welded to the shell. While cheaper in cost, this prohibits the mechanical cleaning of the shell side of a condenser. In a dirty process, such as vacuum distillation, it is more common for a removable bundle to be selected. Floating head or U-tube bundle designs often utilize sealing strips. The internal baffles cannot be welded to the shell, as that would prevent the bundle from being removed. However, the baffling needs to seal to the shell to prevent vapor bypassing. This is where sealing strips are utilized, as shown in **FIG. 1**.

FIG. 1. Sealing strips are utilized to seal to the shell to prevent vapor bypassing.

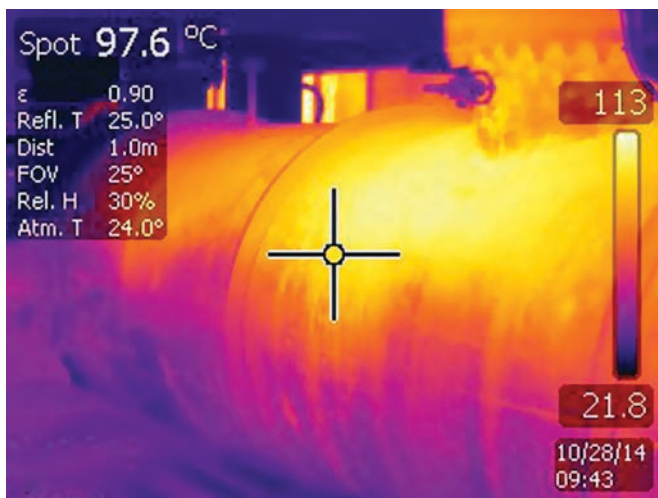
Discussion and onsite assistance identified that the condenser bundle sealing strips were not replaced during the turnaround. The condenser bundles had either been installed without sealing strips or the original sealing strips were severely damaged. Thermal images of the condensers (FIG. 2) were taken, and the temperature profile indicated bypassing through the sealing strips. This bypassing steam acts as a load to the downstream and, in this case, that bypass was severe enough that it was overloading the ejectors. This was directly responsible for the tower's poor performance.

FIG. 2. Thermal images of the condensers were taken and indicated bypassing through the sealing strips.

After the bundles were reinstalled with new sealing strips and the system was brought back online, the vacuum returned to the design of 15 mmHgA. To prevent this from reoccurring, this refiner has placed a hold point for engineering to inspect the cleaned bundles and verify new sealing strips have been installed prior to bundle reinstallation on all future condenser work.

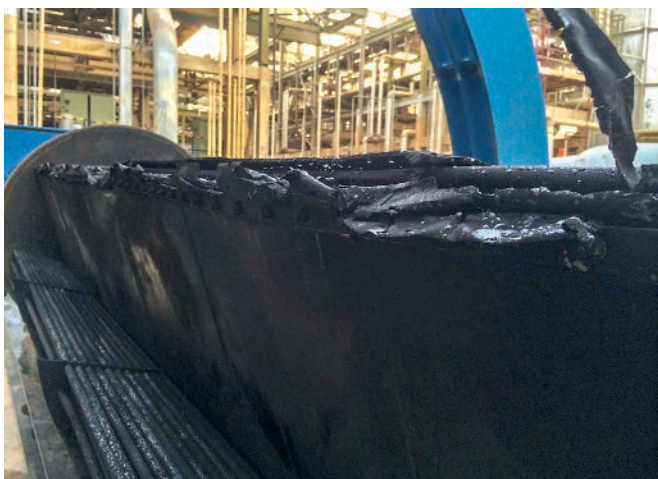
FIG. 3. Damaged sealing strips.

The refiner procured the required sealing strips and placed them into stock. Within 1 yr, an opportunity presented itself when the boiler that supplies steam to the ejector system had an unplanned outage. The refiner used this opportunity to pull the condenser bundles and confirmed that the sealing strips were either missing or in very poor condition (FIG. 3).

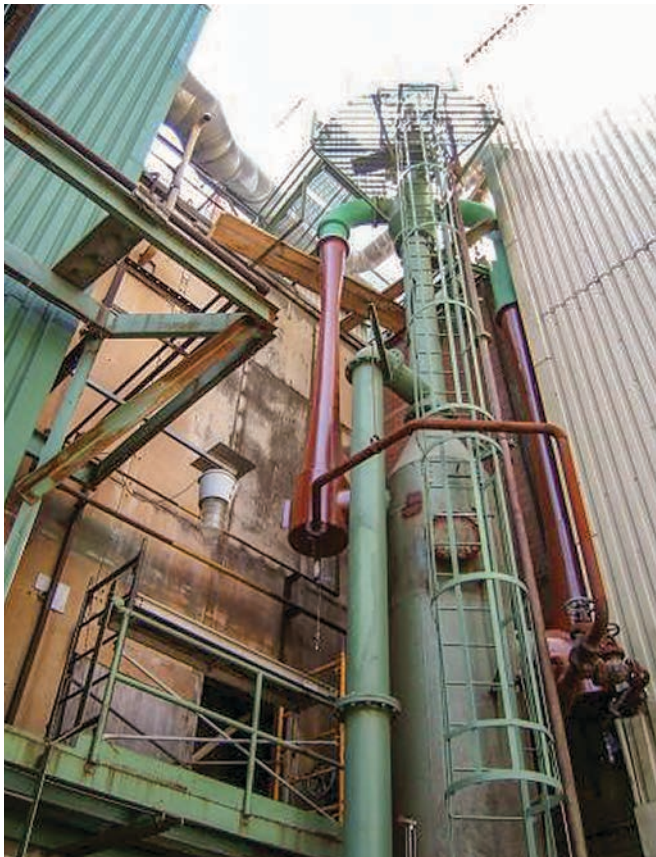
- The replacement diffusers were not concentric. As is often an issue with non-OEM diffusers, the replacement diffusers were oblong, which was negatively impacting performance.
 - The alignment was incorrect, meaning the new diffuser was not straight relative to the air chamber and motive nozzle. When the motive nozzle is incorrectly aligned with the diffuser, the motive steam will be focused towards one side of the ejector, reducing its efficiency.
- Replacement booster ejectors (FIG. 5) were ordered from

FIG. 5. OEM replacement ejectors on an SVRU.

the SVRU's OEM. Following installation, the performance of the system returned to design. Although ejectors appear simple from the outside, precision and alignment are critical. Small,

seemingly unnoticeable deviations can be detrimental to successful performance. Going forward, this site plans a yearly inspection so potential system issues can be identified before they fail, and necessary parts are stocked so that any failure can quickly be addressed.

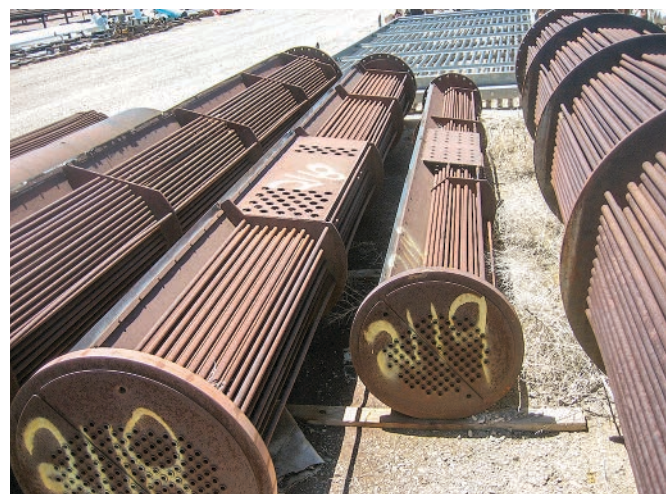
FIG. 6. A maintenance yard filled with failed bundles.

The original stainless-steel bundles lasted roughly 20 yr, whereas the replacement bundles lasted 18 mos. This short service life was due to the carbon steel oxidizing and developing a multitude of cooling water leaks. Another unfortunate side effect of selecting carbon steel is that rust buildup on the tubes impedes heat transfer and restricts cooling water flow, resulting in a reduction in performance. Although carbon steel works well at first, its performance quickly dissipates, resulting in tower instability and poor vacuum. As leaks develop, vast amounts of cooling water are also lost into the waste stream, increasing the load to the water treatment plant.

Due to the constant failure of the carbon-steel bundles, the refinery began replacing them every shutdown going forward. Before reaching out to the OEM for assistance, a total of 18 new carbon-steel condenser bundles were purchased from the heat exchanger vendor and installed, far exceeding the cost of stainless bundles. FIG. 6 shows failed bundles waiting to be scrapped. Replacing bundles has additional ancillary costs beyond the bundles themselves that include planning, shipping costs, cranes, additional manpower and lost production.
