How to improve ejector system performance

This article describes four case studies in performance problem solving taken from a variety of documents produced by ejector system experts.

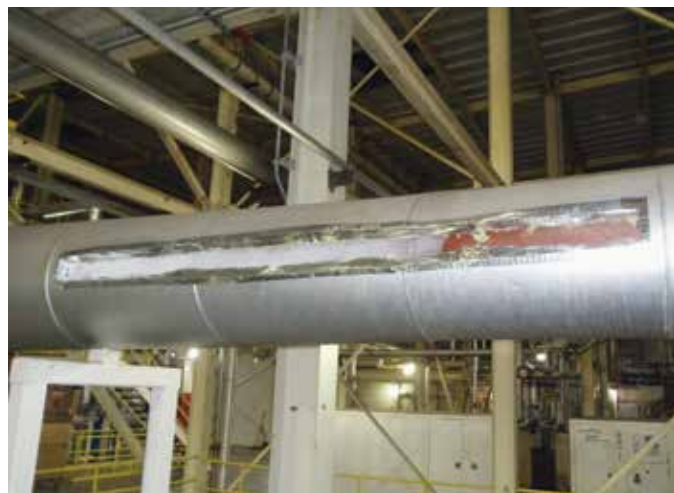
Figure 1. Insulation removed from the first stage ejector, showing frost formation. Source: Graham Corporation

The engineer determined that as the batch process began ejector performance was acceptable. Then, ice began to form inside the ejector along the inlet diffuser. As the ice grew thicker, the cross sectional flow area of the ejector decreased, disrupting flow and increasing pressure loss.

information on thermodynamic fundamentals and an illustration for what was occurring. Although motive steam is hot, the process loads to the ejector are warm, and the ejector exhaust temperature is hot, ice can (and will) form when operating pressure is below water's triple point, specifically when inlet pressure to an ejector is below 4.6 mm Hg absolute. When operating below this pressure, the inlet diffuser must remain hot to avoid ice formation. An ejector should be designed and constructed accordingly.

Ideally, the ejector should have had a steam jacket that kept the inlet diffuser metal surface above the freeze point of water. The root cause of this manufacturer's problem was a lack of heating on the inlet diffuser. The engineer recommended a retrofit electrical steam tracing.

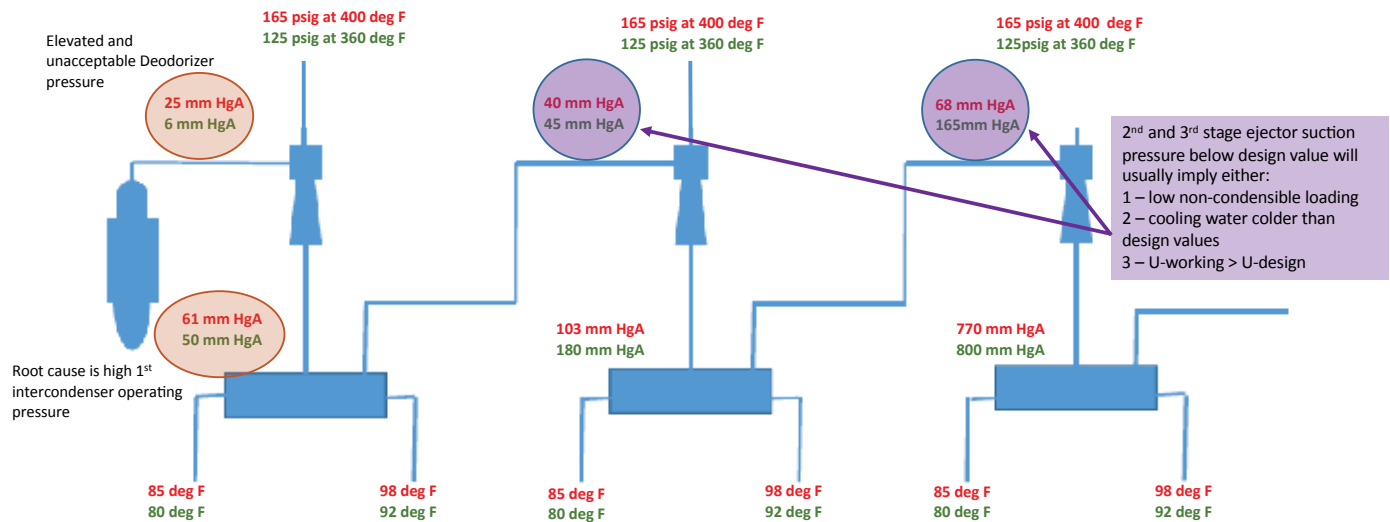
Figure 2. Deodorizer column ejector system with the design specifics in green and field measurements in red. Source: Graham Corporation

The first stage ejector was operating with a backpressure above its maximum discharge pressure capability and consequently the deodorizer pressure rose.

The operating variable responsible was a cooling water temperature at 85 degrees Fahrenheit (F) rather than the design specification of no warmer than 80 deg F.

The problem was further exacerbated by a motive steam pressure running at 165 psig rather than 125 psig. The higher pressure meant greater motive steam consumption and higher heat injection needed for the condensers.

The first inter-condenser seemingly had a high pressure drop on the vacuum side. That was due to the second stage ejector over venting the condenser; meaning, it was pulling more vapor along with the air in order to match the vapor load handling capability of that ejector. However, the over venting caused no particular issue for the ejector system. The warm cooling water and higher motive steam pressure were the root cause, with warm water the primary issue.

The only practical and long term beneficial path to take for the refiner was to replace the first stage ejector and first intercondenser appropriately designed for cooling water at 85 deg F inlet and 165 psig motive. Upon doing so, performance was fine.

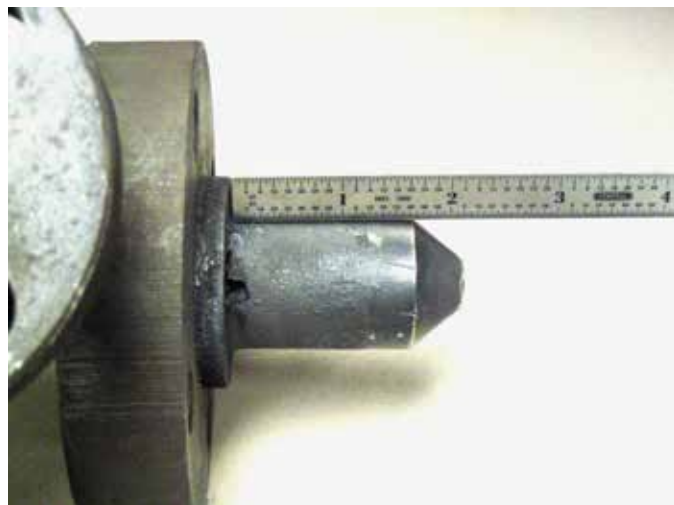
Figure 3. A steam nozzle with a hole through which motive steam leaks into the suction chamber of an ejector. Source: Graham Corporation

The improvement engineer requested a system shut down so the fourth stage ejector could be pulled from the system for inspection. The ejector was disassembled and inspected. Visual inspection determined that a hole developed in the steam nozzle assembly. This caused steam to leak into the suction chamber of the fourth stage ejector and increase the mass

flow rate it had to handle. The suction pressure then increased above the third stage ejector maximum discharge capability. The result was the ejector system could not function.

The improvement engineer learned that, against best practices, the ejector system had been in operation for about 10 years without maintenance or replacement parts. All refiners should adhere to routine maintenance guidelines (see box).
